## *Bressingham Church*

*Heritage Lottery Fund building repairs blog: by Linda Holly*

Building works finally begin at Bressingham Church!

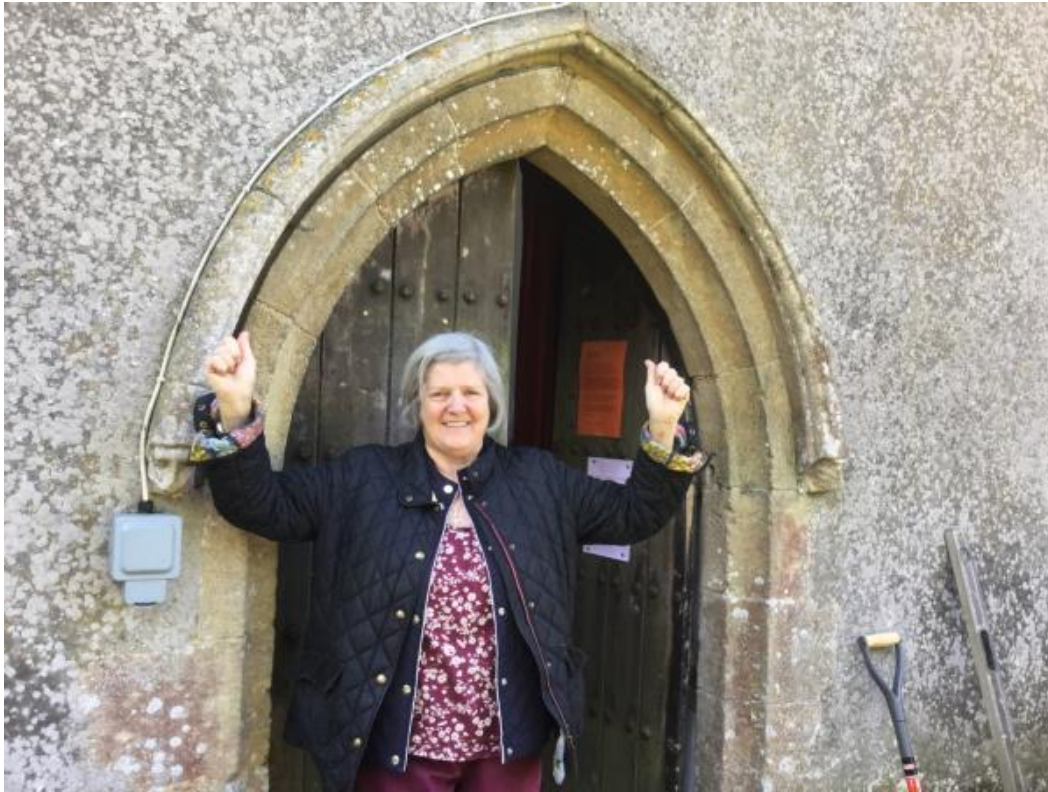
Diana Burroughes, Churchwarden, and I met Keith and Alex (builders) at the church. Stage I is groundworks, digging soakaways. Keith was adept at driving and turning the mini-digger up the church path.

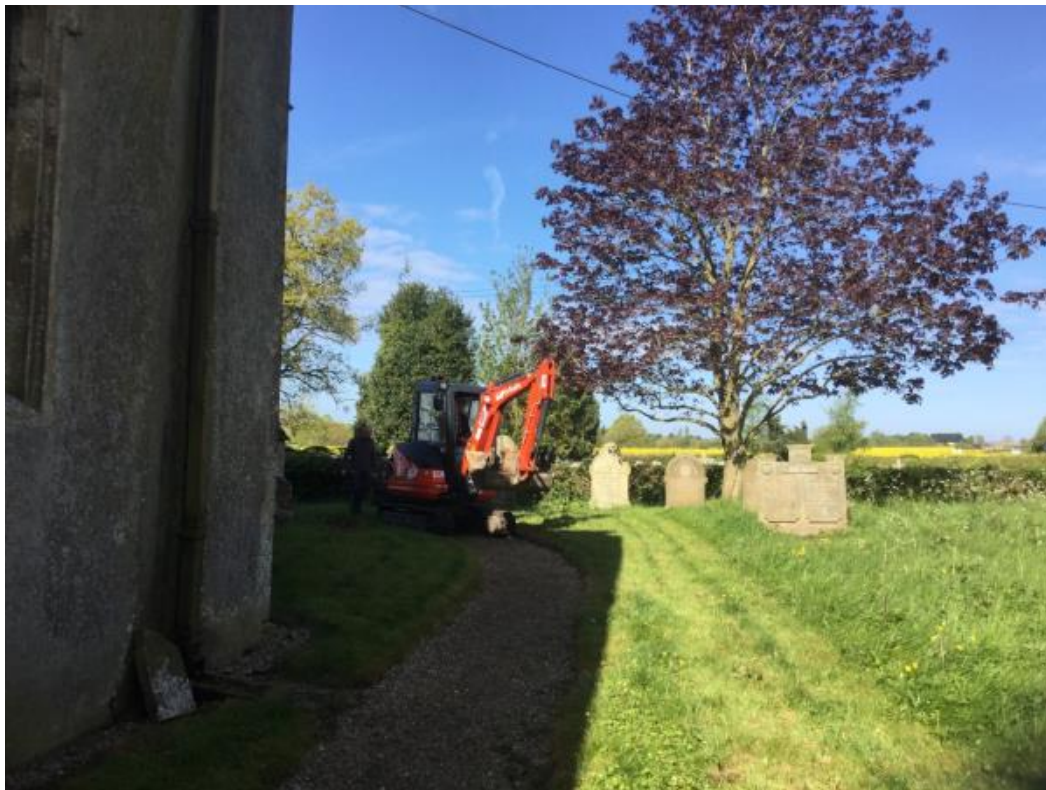
Archaeologist Sarah Bates oversaw the digging. Unfortunately, several burials were discovered beneath the path from the Lych gate to the north door which indicates the remains are certainly older than the path! The remains will be carefully documented and reburied by Diss Team clergy.

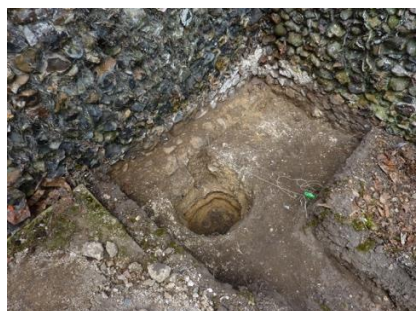
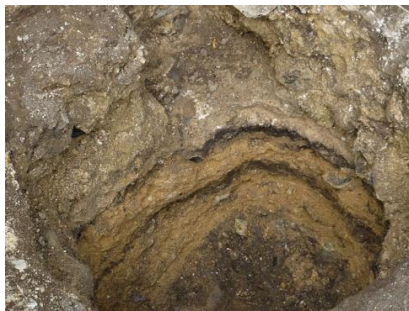
Groundworks continue at the church. Archaeologists Sarah and Simon are still carefully removing bones from the soakaway trench. Sadly, some of the remains they found last week were young children. (A reburial service will take place in the next few weeks). Some interesting archaeology has been discovered in the church: Sarah and Simon noted layered foundations in the holes next to the 13<sup>th</sup> century chancel north wall (close to the north aisle) that had to be dug ready for the new downpipes. These black stripes indicate they date from the 12<sup>th</sup> century.

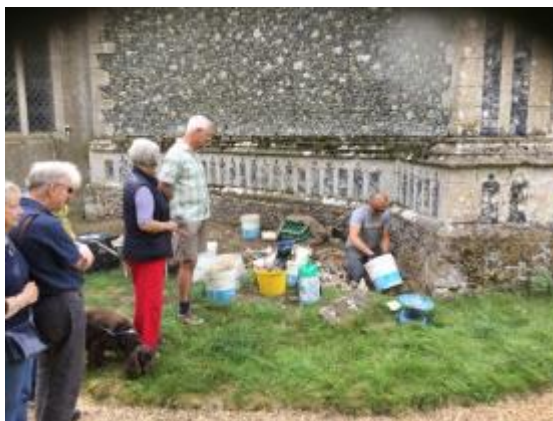
Tim and Lee were excellent instructors showing how best to repair flint walls. Tim recommended a mix of three parts sharp sand to one part hydrated lime, with enough water added to make a pliable but not too wet mix. Tim guided attendees how best to apply the mix with a trowel. Tim waits for the lime to set sufficiently, then pushes the lime deep into the wall. Once set, the lime is brushed off and wiped. The repaired wall will then be left slowly to dry.....Hessian covering helps prevent the lime setting too quickly in sunny locations. Volunteers discovered it is not as easy as Tim makes it appear – but of course he has decades of experience! Thanks to Tim, Lee, Howard and Paul for their cooperation.
